Arboricultural Report

Tree Survey,
Arboricultural Impact Assessment &
Arboricultural Method Statement

No. 2 Firhouse Road and the former 'Morton's The Firhouse Inn'
Firhouse Road
Dublin 24

200930-PD-11-A

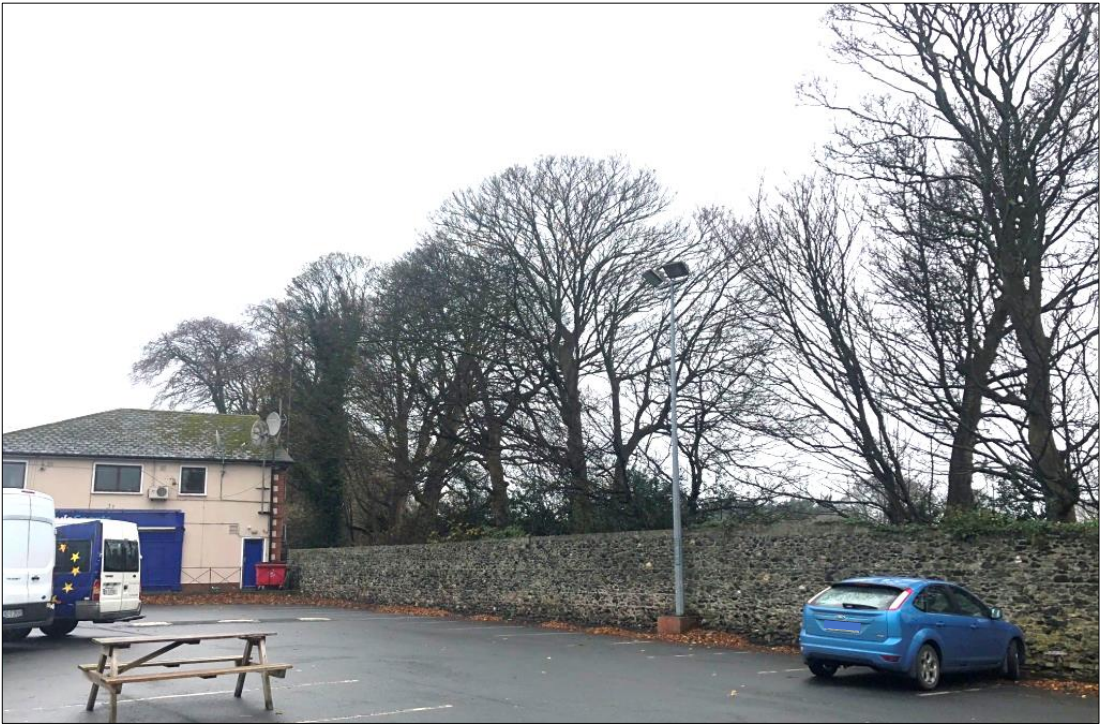
Image 2: View of the neighbouring trees T21 to T27 located along the north-western boundary of the site.

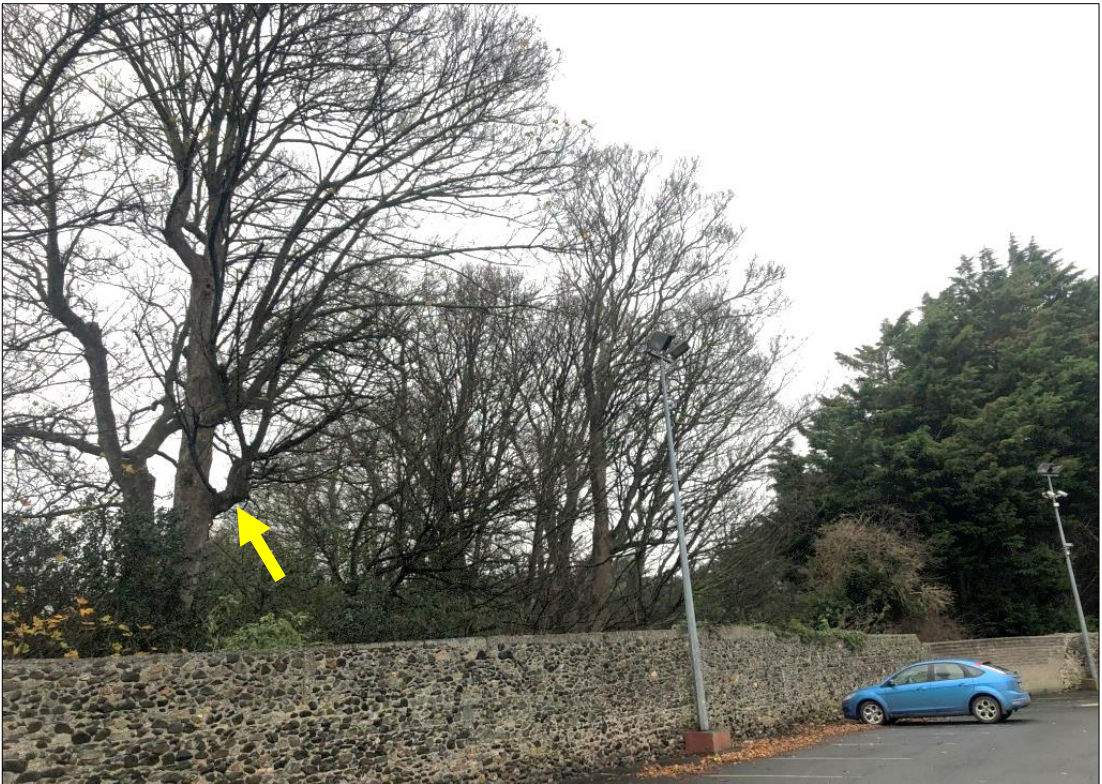
Image 3: View of the neighbouring trees T27 to T30 located along the north-western boundary of the site. Note the lower laterals of T37 have previously been cut back to the boundary.

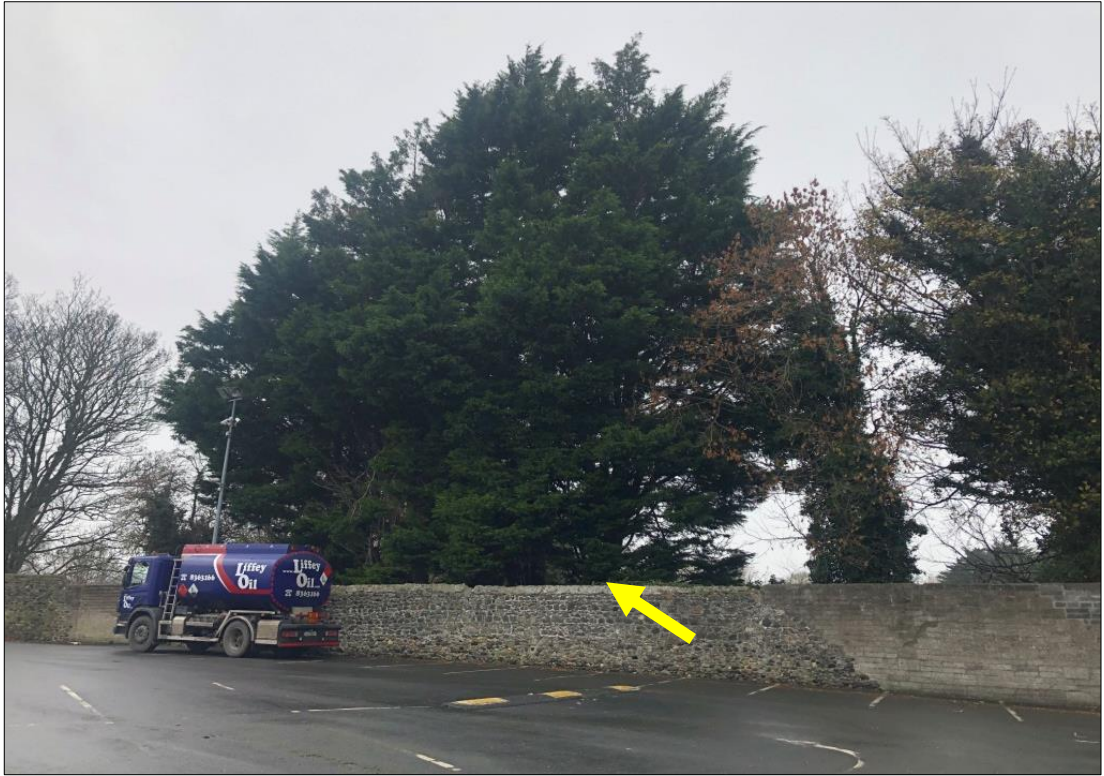
Image 4: View of the Leyland cypress trees T32 to T36 located adjacent to the northern part of the boundary. Note the lower laterals have been previously cut back to the boundary.

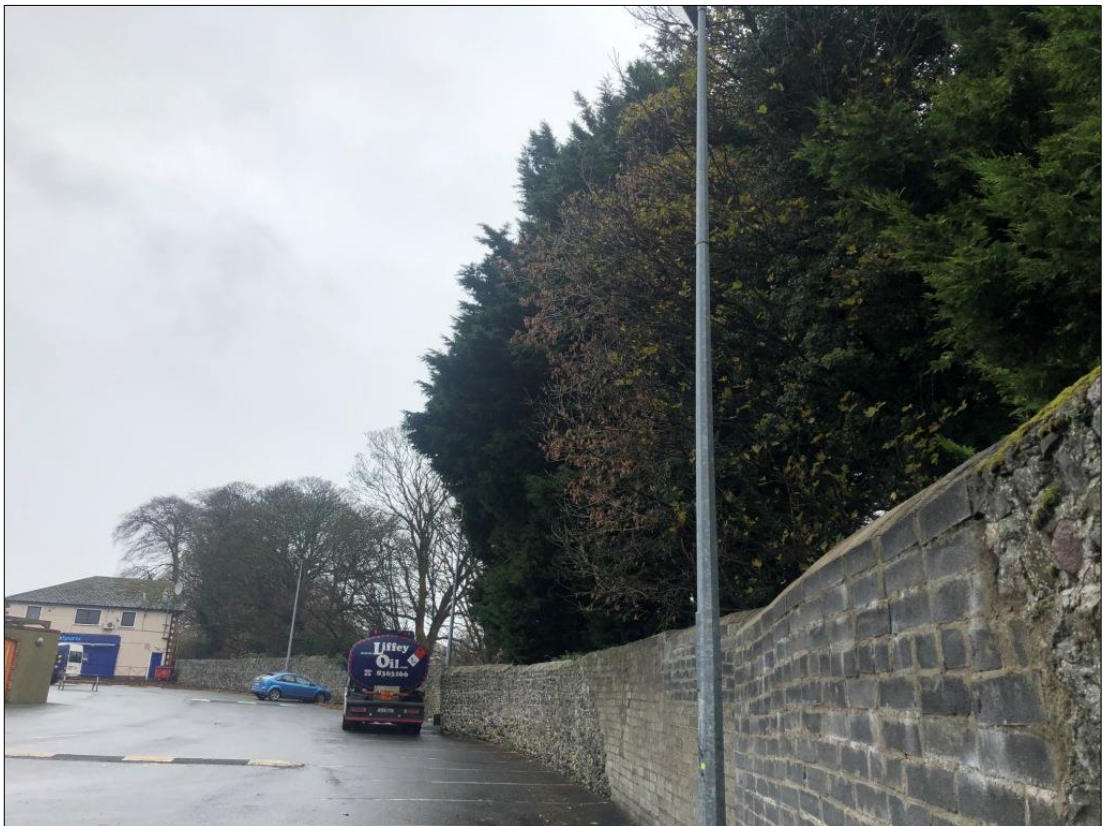
Image 5: View along the boundary wall showing the minor extent that which branches are overhanging the site.

- 6.1 **Loss of trees** – The proposed development does not require the removal of trees.
- 6.2 **Pruning works to facilitate the development** – The lower overhanging lateral branches of neighbouring trees are required to be reduced back to the boundary line in order to provide sufficient space and clearance for construction works to be carried out.
- 6.3 In certain instances, overhanging lateral branches have been previously reduced back to the boundary and have regrown, refer to Images 7 and 8. Taking the past management works into consideration, along with the minor extent of pruning works that are required, these works will not have an adverse impact on the health or visual appearance of the trees. Details of the proposed pruning works are specified within the Tree Work Schedule at Appendix A.

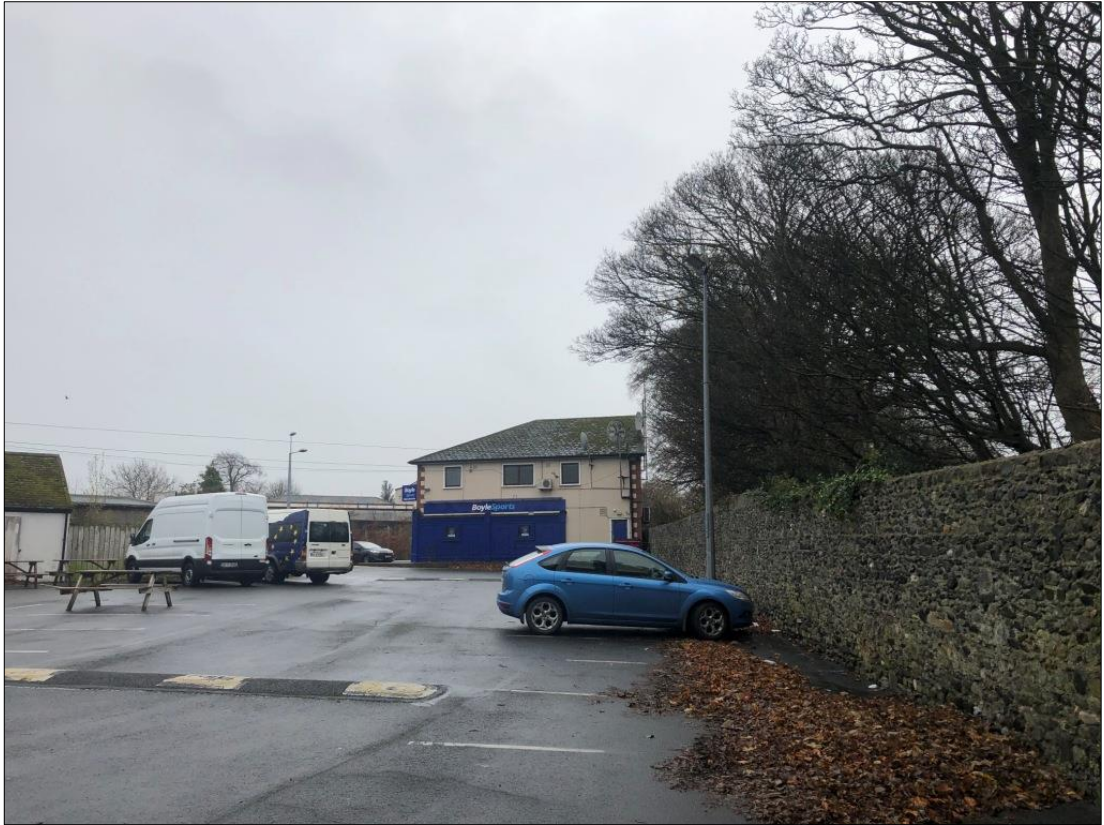
Image 6: *Second view along the boundary wall showing the minor extent that which branches are overhanging the site.*

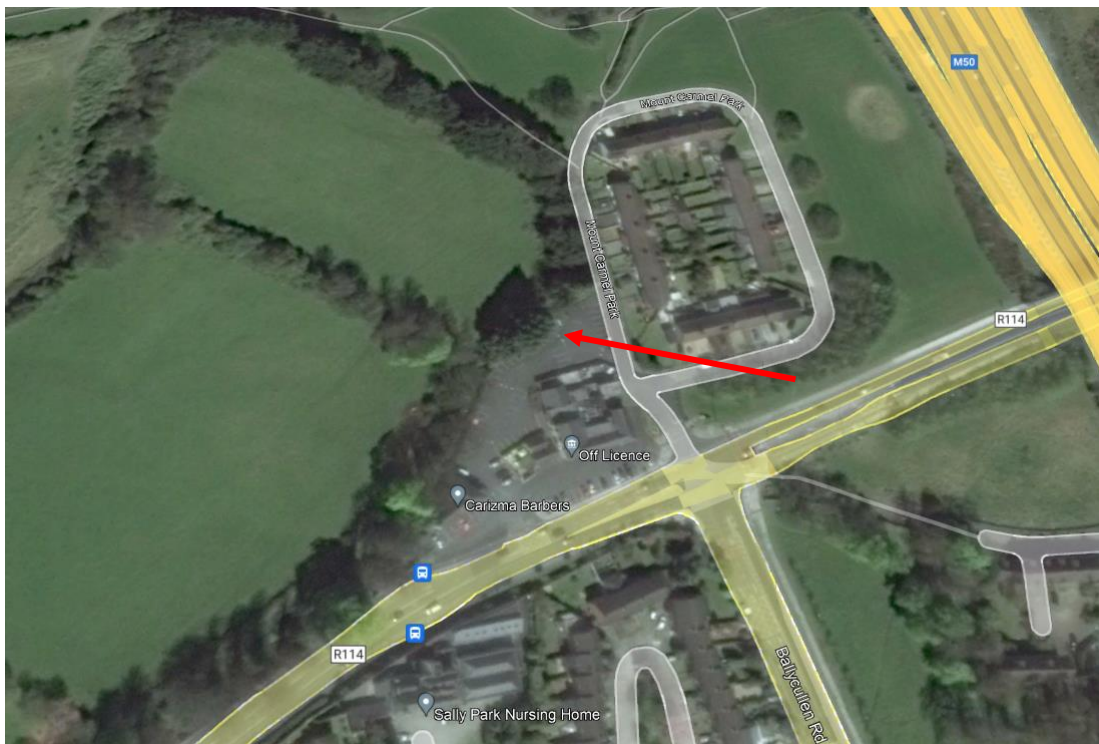
Image 7 (Google Earth 2015): Aerial view of the site in 2015 showing the branch growth beyond the site boundary.

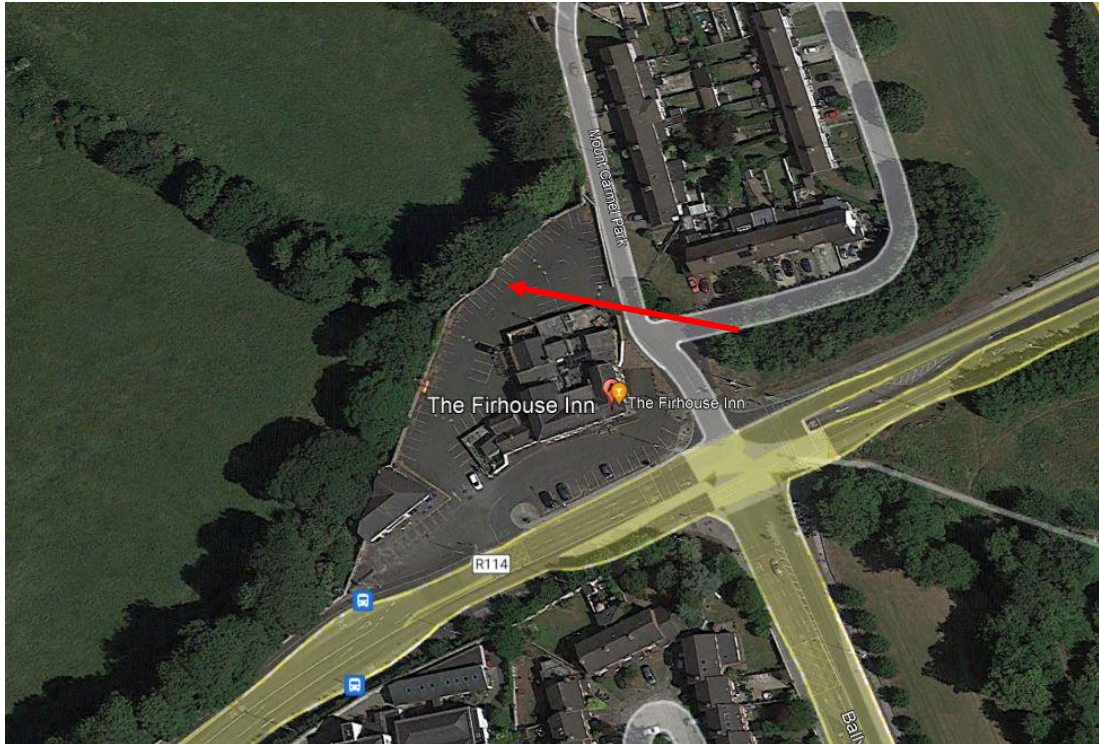
Image 8 (Google Earth 2018): Aerial view of the site in 2018 showing the branch growth has been cut back to the site boundary.
