PRELIMINARY ENVIRONMENTAL SITE ASSESSMENT

Firhouse Road, Firhouse, Dublin 24

BLUEMONT DEVELOPMENTS (FIRHOUSE) LTD.

PROJECT NO. T255/1

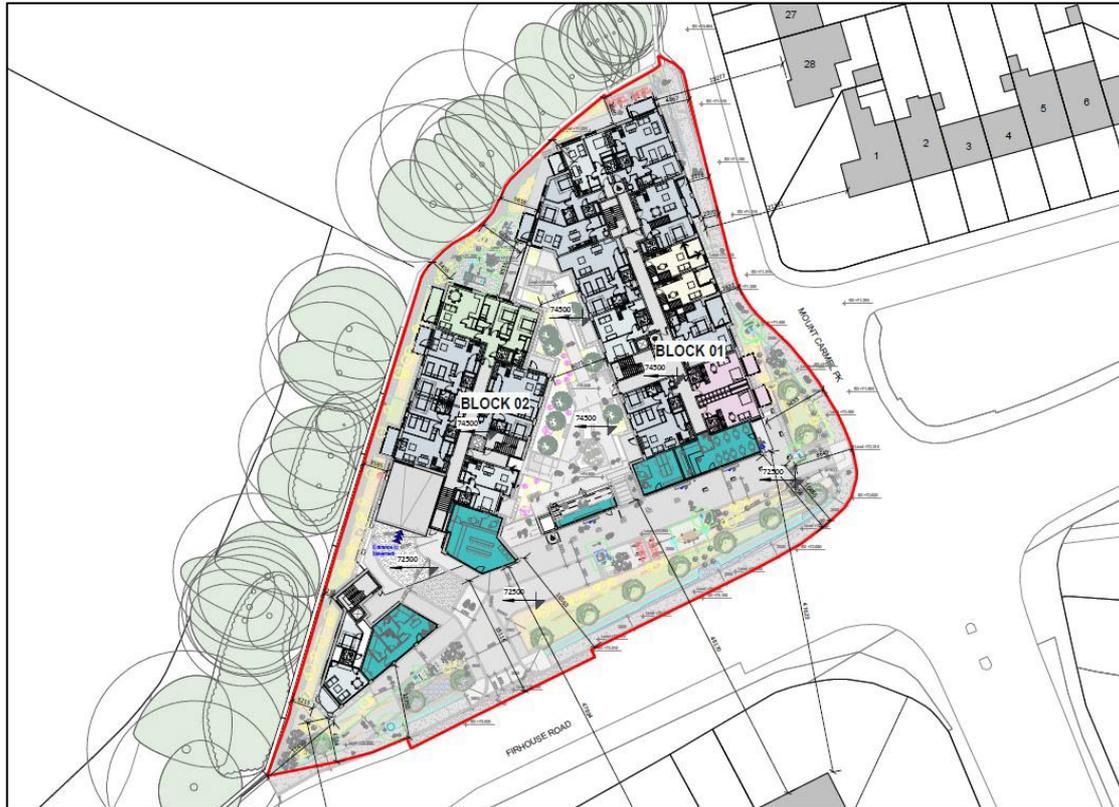
Figure 1.3: Proposed Site Layout Plan

The development with a total gross floor area of c. 11,638 sq m, will consist of 100 no. residential units arranged in 2 blocks (Blocks 01 and 02) ranging between 3 and 5 storeys in height, over lower ground floor and basement levels, comprising:
